Monitoring and Evaluation of the Nisqually Delta Restoration Project

Period: June 2009 to September 30, 2010

Final Report for Agreement: DW-14-95762601-0

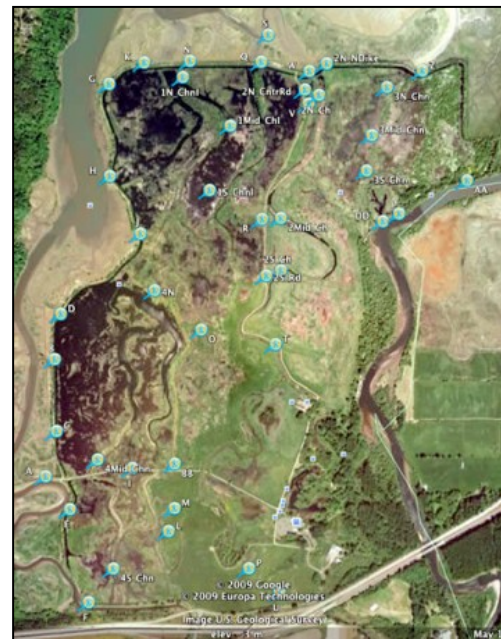
Figure 3. Photopoints selected for repeat photo-documentation during Nisqually restoration process.

Photo-documentation provides an economical and effective way to qualitatively document restoration progress over time. Pre-restoration, photopoints were selected at 42 sites throughout the project area to show hydrological and vegetative changes as a result of restoration actions (Figure 3). Photos were taken from left to right, in full 360 degrees with overlapping edges, to allow the photos to later be stitched together using computer software to create unified panoramic images. By returning to the same points over time, these panoramas will provide visual documentation of large-scale changes during the restoration that provide context for describing the quantitative measures of change the Nisqually system.

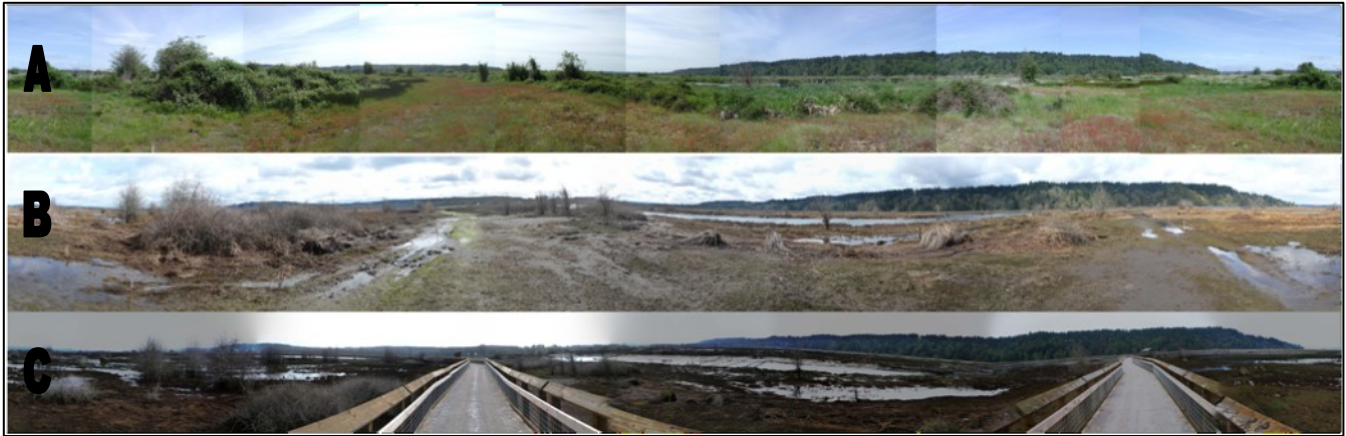
Figure 6. Example of Nisqually photodocumentation from Shannon Slough North: A) Pre-restoration (Summer 2009), B.) Post-restoration I (April 2010), and C.) Post-restoration (October 2010).

Pre-restoration photopoints were selected and photographed in the summer of 2009 to visually document the landscape before tidal restoration. These points were rephotographed in April and October 2010 to provide a qualitative time series of the restoration process. Figure 6 below shows an

example repeated panoramic images. The Unit 4 pre-restoration image (A) depicts the vegetation patterns of the diked landscaped during peak seasonal growth, (B) shows the site approximately seven months post-tidal restoration, and (C) captures the site a year after the dike was breached from a newly-installed public access boardwalk.

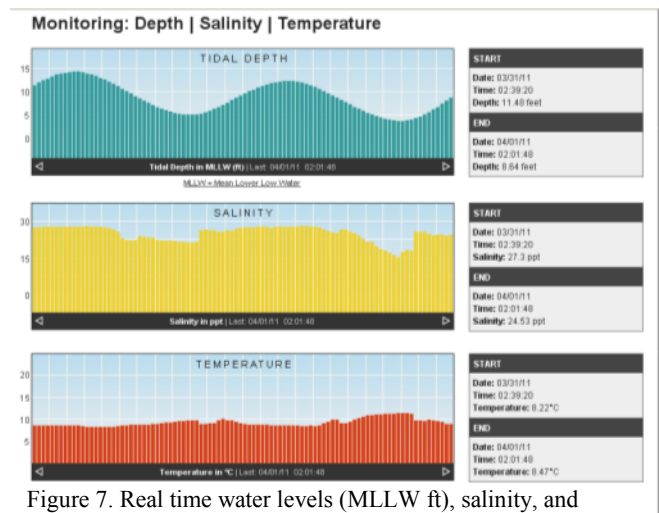
Figure 7. Real time water levels (MLLW ft), salinity, and temperature in the Nisqually Delta over a 24 hour period.

Hydrology and water quality: Restoration Area Six water level loggers (Solinst, YSI and Telog Instruments) and staff gauges were installed along McAllister Creek, Nisqually River, and Red Salmon Slough prior to the breaching of the dike. Following tidal restoration, loggers were routinely maintained and downloaded to monitor the hydrologic development of the project site. We've recorded a tidal range of 14-16 feet at our logger at the Nisqually Reach Nature Center and current data is posted on our website: www.nisquallydeltarestoration.org (Figure 7).

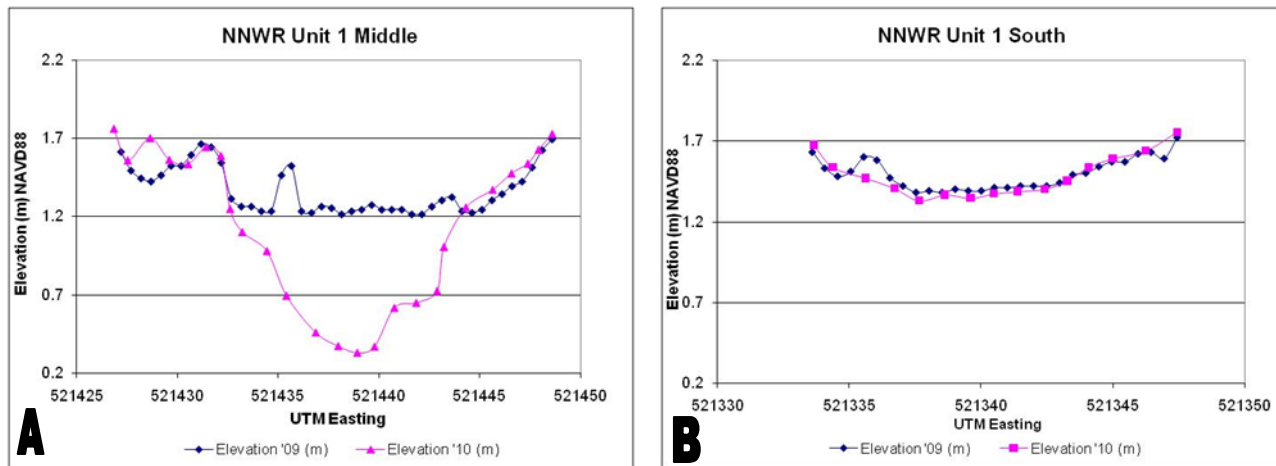
Figure 9. Channel cross-sections from Unit 1 comparing channel morphology from the middle reach of the channel (A) to the southern portion of the channel, furthest from the Dike (B) between 2009 (blue) and 2010 (pink). Moving from the west to east banks of the of the channels along the x-axis, the line represents the elevation of the channel bottom at a 0.5 m scale. The Middle location deepened by almost a meter from pre- to post-restoration while the South section remained relatively unchanged.

Channel cross-sections were completed pre-restoration (Summer 2009) and post-restoration (Fall 2010) at the north, middle, and southern portions of Shannon, Unit 1, Leschi, and Unit 3 tidal channels. Prior to restoration, the elevation of the channel bottom at Unit 1 middle was relatively even with approximately a 0.5 meter range between the top of the bank and channel bottom (Figure 9). After tidal restoration, the channel eroded almost 1m at the deepest point of the V-shape channel. In comparison, channel cross-sections at the southern portion of Unit 1, in the marsh interior, remained relatively unchanged. These results are likely due to greater water velocity with proximity to the channel mouth.

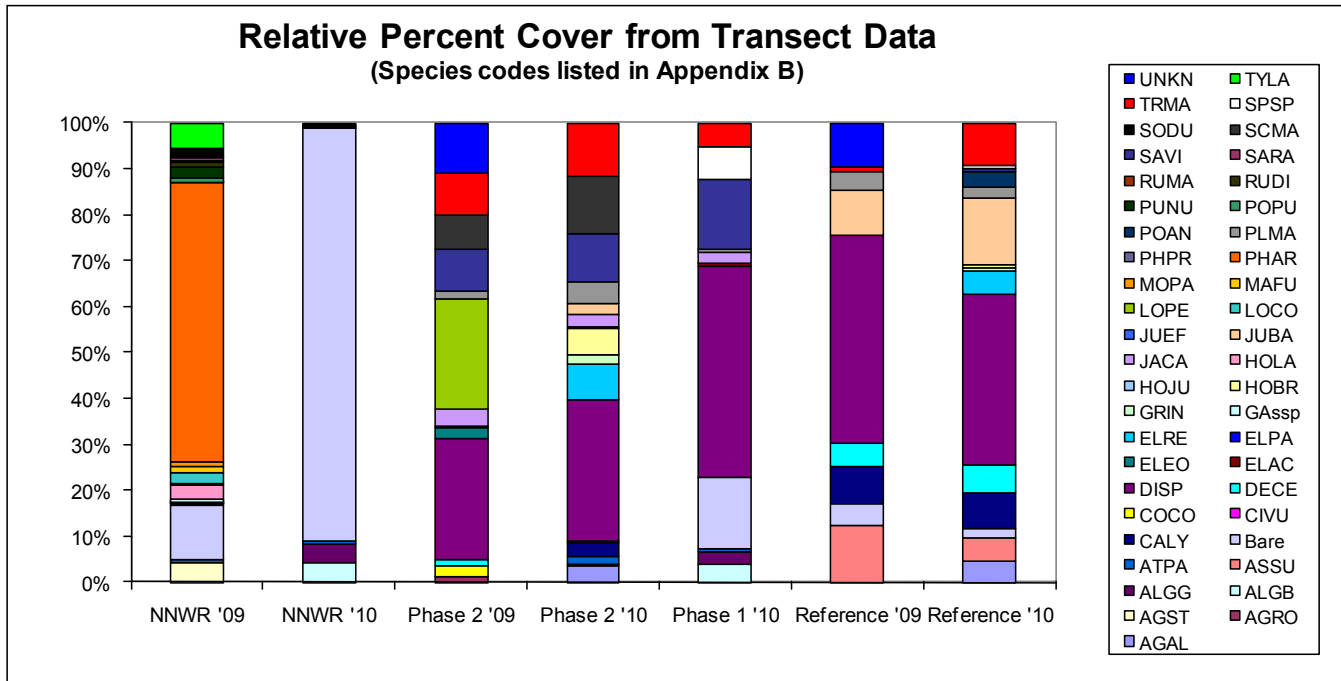
Figure 12. Relative percent cover along permanent vegetation transects in 2009 and 2010. Sites are Nisqually NWR (NNWR), Phase 2, Phase 1, and Reference.

We detected a total of 85 plant species in a single pre-restoration vegetation survey in 2009 and a single post restoration vegetation survey in 2010 (Appendix B). Our transect and quadrat vegetation surveys across the Refuge prior to restoration detected over 75% cover of invasive species, primarily reed canary grass (*Phalaris arundinaceae*; Figure 12), which had an average height of 1.2 m. In comparison, the Phase 2 restoration and reference marshes on the west side of the Nisqually River consisted of a mixed community of tidal marsh species such as salt grass (*Distichlis spicatum*) and perennial rye grass (*Lolium perenne*). Reed canary grass was not detected in the restored Phase 2 or Reference marshes.

One year following restoration, we detected less than 1% reed canary grass cover along permanent transects within the Refuge. The Phase 2 restoration and reference marshes continued to be represented by a mixed species community with salt grass (*Distichlis spicatum*), pickleweed (*Sarcocornia pacifica*), and baltic rush (*Juncus balticus*).

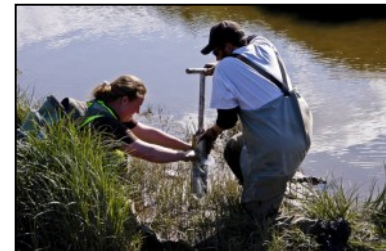
Figure 13. Collecting benthic cores at Phase 2. Photo by J. Wieser.

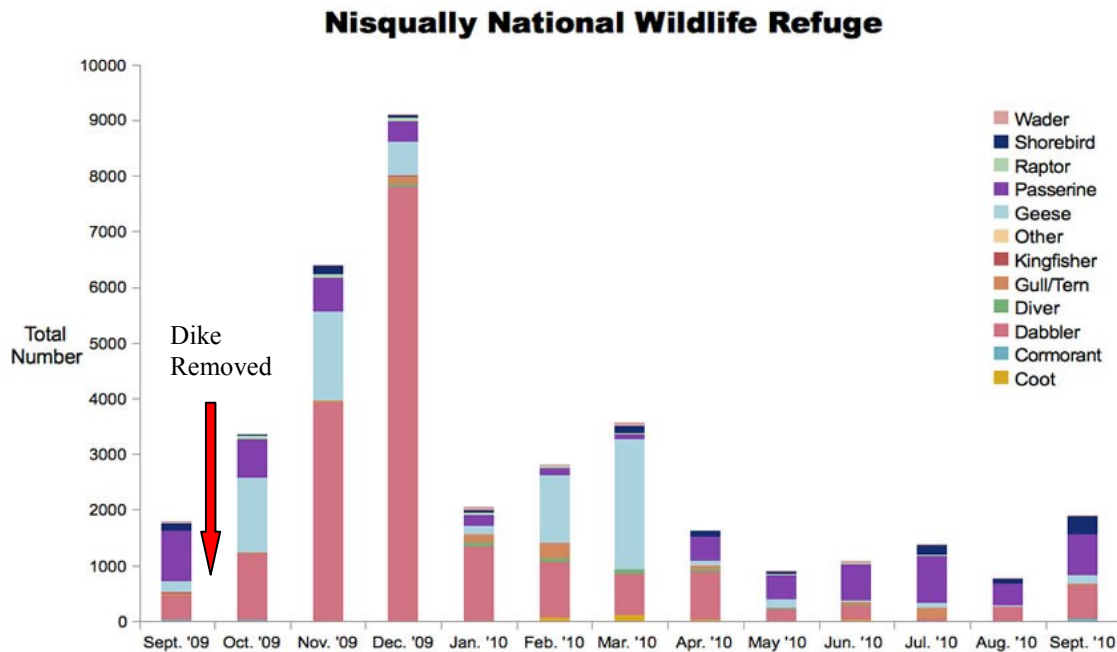
Figure 14. Total birds by foraging guild observed by month at the Nisqually Refuge from September 2009 – 2010.

During a single pre-restoration bird survey, less than 2,000 birds were counted in the project area and were largely composed of passerines and dabblers (dabbling ducks; Figure 14). The single pre-restoration survey represents only a snapshot of pre-restoration site conditions during a time when the interior was drained in preparation for dike removal. Thus we focus on post restoration bird trends.

We detected 138 bird species during our monthly post-restoration bird surveys. Bird abundance varied by season: dabblers, such as American wigeon (*Anas americana*) and Northern Pintail (*Anas acuta*), had the greatest abundance in December (almost 8,000 dabblers) and almost 2,000 geese (primarily Canada [*Branta canadensis*] and Cackling [*Branta hutchinsii*]) were counted in large flocks in March. During the late spring and summer, overall waterfowl abundances declined because of migration to spring/summer breeding grounds, but passerines, such as European starlings (*Sturnus vulgaris*) and cliff swallows (*Petrochelidon pyrrhonota*), increased in spring. Overall, shorebird detection remained
