# The Benicia-Martinez Restoration Project: 2007 Open-File Report

**Western Ecological Research Center, San Francisco Bay  
Estuary Field Station in cooperation with California Department  
of Transportation, District 4**

Report Series XXXX-XXXX

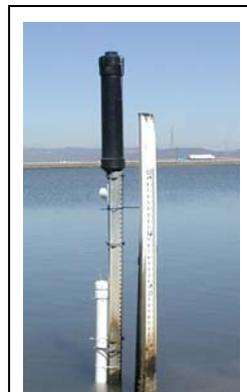
**Figure 3.** Tidal Water Level Station.

Two tidal water level stations were installed in the interior of the project near the culvert (TS 1) and one in the intake channel to Suisun Bay (TS 2). The tidal water level system (R-2100e and WLS-31, Telog Instruments, Inc., New York) included a pressure transducer that was placed underwater near the sediment surface, a datalogger that converted water pressure to water depth and recorded data, and a staff gage in which water levels were referenced to NAVD88 ft (Figure 3). Data was downloaded every 60 days and periodic location adjustments were made due to sedimentation patterns and channel development. In addition, periodic spot checks were conducted to test for equipment functioning, sediment buildup near the sensor, and sensor drift. Loggers were moved to deeper water, if possible, when sediment buildup was detected at the sensor. Gaps in the data result from periods when the loggers malfunctioned and were replaced.

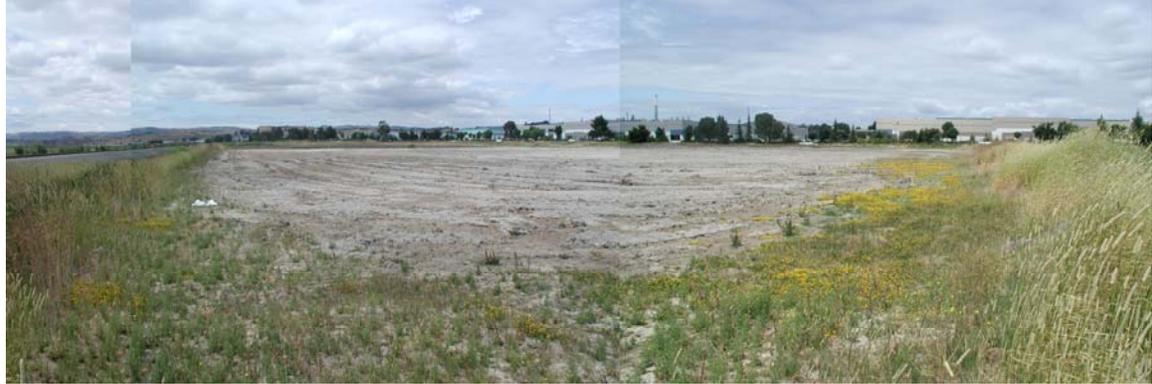
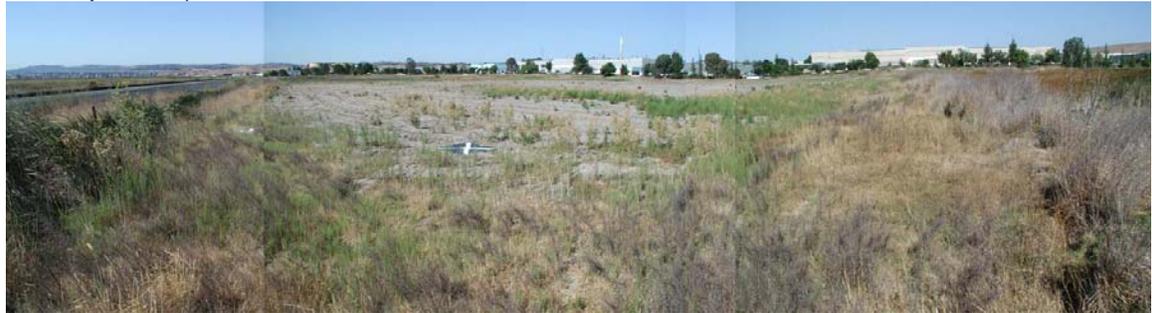
Photopoint 4) Northeast corner in 2006

Photopoint 4) Northeast corner in 2007

**Figure 12.** Photopoints provide qualitative documentation of change over time. At photopoint 4, we see increased vegetative growth in 2007.

We took annual panoramic photographs at seven permanent locations in July 2006 and August 2007 (Figure 2). The 2006 images clearly show that the upland portions of the site were dominated by the non-native weed stinkwort (*Dittrichia graveolens*) and that vegetation colonization within the upland TCE-capped area was bare (Figure 12). This largely bare area, was utilized by American avocets for breeding. The 2007 images qualitatively show the amount of vegetation establishment within the marsh plain, which was dominated by common pickleweed (*Sarcocornia pacifica*) and brass buttons (*Cotula coronopifolia*).
